# Manhole Inspection Summary

Manhole # S29GG2016MH

Insp Date: **11/22/06 9:33 AM**

**Location** Address: **1 BELLEMORE RD**

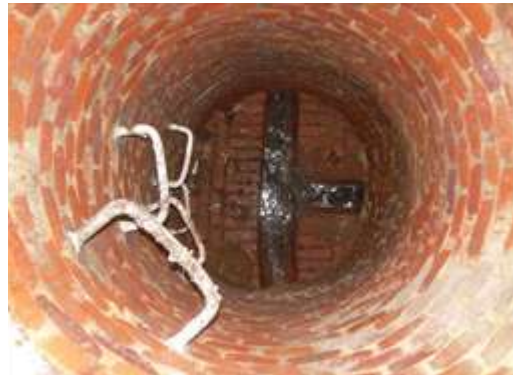
Top View

Adjustment and Barrel infiltration. Bench and Channel debris.

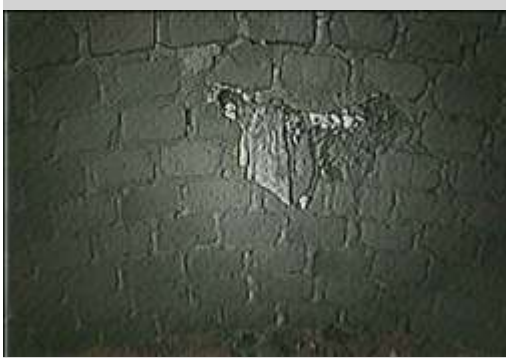
Defect

Evidence of surcharge.

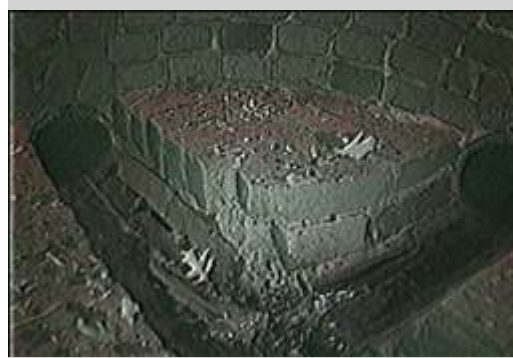
Defect

Channel deterioration.

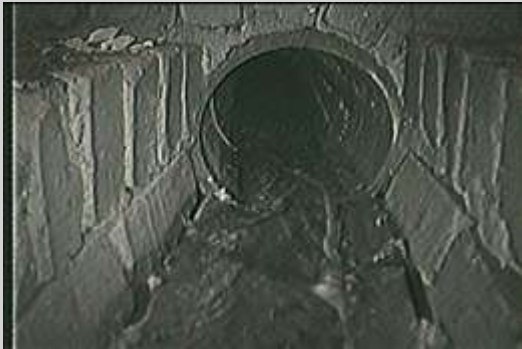
### 8 in. Circular Gravity Sewer Pipe Out @ 12 O'Clock

Infiltration: **Evidence** Pipe Seal Cond: **Unknown**

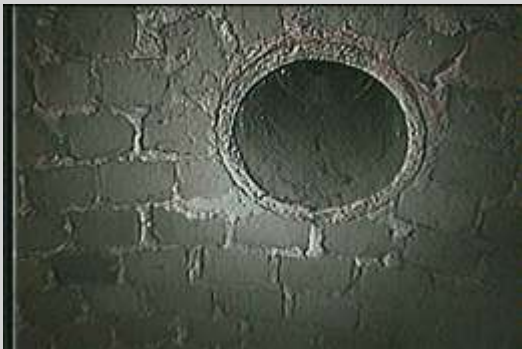
### 8 in. Circular Gravity Sewer Pipe In @ 3 O'Clock

Infiltration: **Evidence** Pipe Seal Cond: **Unknown**

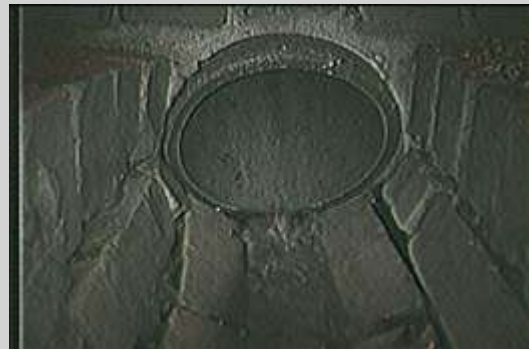
### Drop In @ 3 O'Clock

Channel deterioration.

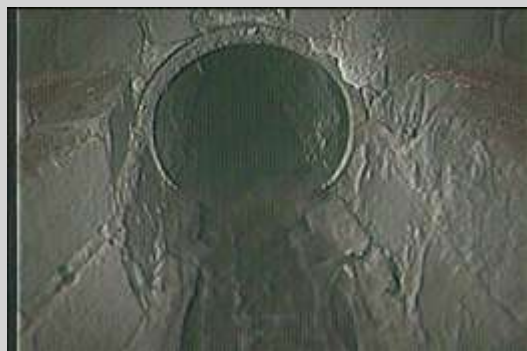
Pipe In @ 6 O'Clock

Infiltration: **Evidence**
